**Flood Control Project Maintenance  
Levee Inspections**

**Fall 2019 Levee Maintenance Deficiency Summary Report**

**Flood Control Project Maintenance  
Levee Inspections****LMA District Cover Sheet****Fall 2019 Levee Inspection Results****Sutter Maintenance Yard East-West Interceptor**

**Sutter Maintenance Yard East-West Interceptor**

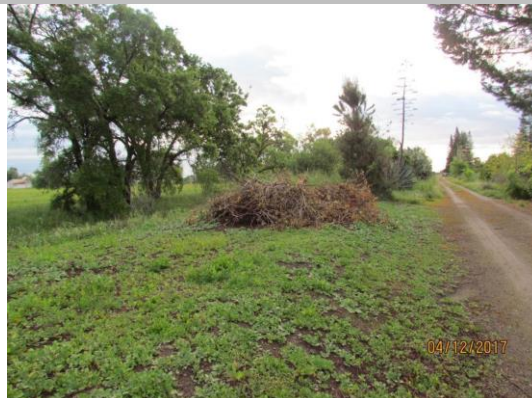
Photo 1 of 1 : FA\_2019\_ST0020\_213\_12\_20190822\_00001.jpg

LM Start	0.20	Rating **	M	Issue No.	12
LM End	0.20	Issue Type +	En	Location *	WS
Category	Earthen Levee			GPS Latitude/Longitude	
				Start	End
Item	Encroachments			39.171565 °	39.171565 °
				-121.756293 °	-121.756293 °
DWR ID	DWR_ST0020_01_s_2017_12				
Comment Code					
PR : Prunings					
Inspector Comment					
Remove the prunings from the waterside slope.

View of the prunings along the waterside slope.

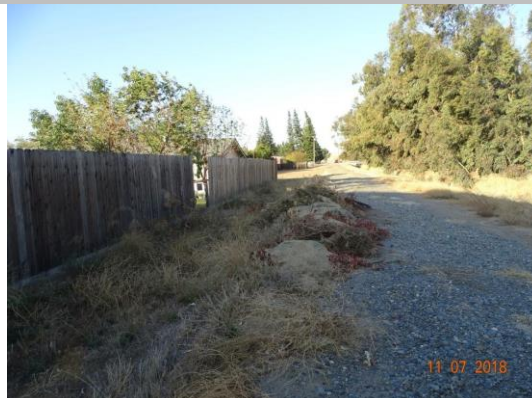
Photo 1 of 1 : FA\_2019\_ST0020\_213\_14\_20190822\_00002.jpg

LM Start	0.45	Rating **	M	Issue No.	14
LM End	0.45	Issue Type +	En	Location *	LS
Category	Earthen Levee			GPS Latitude/Longitude	
				Start	End
Item	Encroachments			39.171453 °	39.171453 °
				-121.751603 °	-121.751603 °
DWR ID	DWR_ST0020_01_f_2018_14				
Comment Code					
PR : Prunings					
Inspector Comment					
Removed the prunings from the landside crown.

View of the prunings along the landside crown.

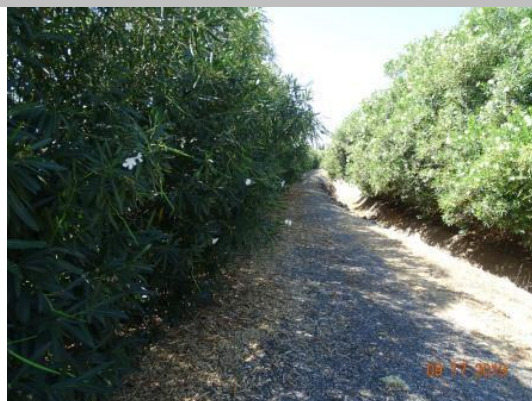
Photo 1 of 1 : FA\_2019\_ST0020\_213\_25\_20190918\_00026.jpg

LM Start	0.51	Rating **	U	Issue No.	25
LM End	0.67	Issue Type +	Ma	Location *	LS
Category	Earthen Levee			GPS Latitude/Longitude	
				Start	End
Item	Trim / Thin Trees			39.171392°	39.171345°
				-121.750478°	-121.747585°
DWR ID	DWR_ST0020_01_f_2016_25				
Comment Code					
T3 : Trim and thin trees to allow visibility of the ground and room to flood fight.					
Inspector Comment					
Olleanders are significantly blocking visibility and access.

View of the olleanders that are significantly blocking vehicle access. Fall 2019.

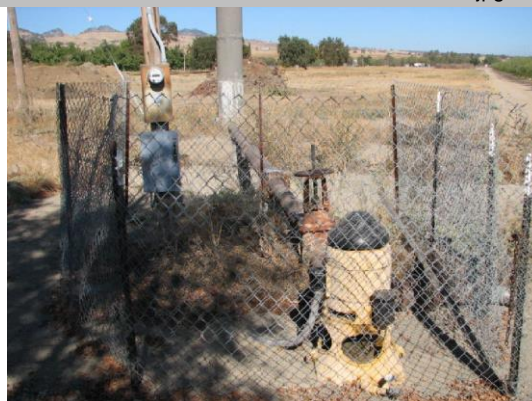
Photo 1 of 3 : UCIP\_FA\_2019\_55464\_11344.jpg

Comment Code						
Inspector Comment						
DS_ID:19417 FS_ID:55464 EP_NO: N/A Repair Type: Non-Urgent Crossing Status: Found UCIP Comments: 02/12/2019 Groundwater system does not cross high ground section (known as project levee). Record will remain part of UCIP's inventory however, pipe does not go through the designated project levee. Record remains Non-Urgent, no permit has been found authorizing this crossing. Groundwater well appears to be abandoned. The power meter has been removed. (O. Magana - DWR UCIP)4/10/2017 Crossing appears to have been abandoned. (DWR Sutter Yard- A Freitag)4/19/2016 Meter has been removed from the power box and the power lines have been disconnected from the pole and pump. Appears this crossing may have been abandoned.05/12/2015 Crossing appears in good condition. No noticeable issues to report.11/17/2014 Same as last inspection.5/12/2014 Same as last inspection.11/4/2013 Same as last inspection.5/15/2013 Same as last inspection. FIELD_STRUCT_DESC: *NOT THROUGH LEVEE* 12-inch steel irrigation pipe crosses over canal above crown elevation. Chain link enclosure on the landside (LS) with pump, power line, and shutoff valve. 24-inch concrete standpipe on unprotected side of canal. [Additional Reference(s): DWR Levee Log, Revised 1990] FS Date: 2/12/2019 10:18:00 AM

Pump, meter, power pole, slide gate, and chainlink fence on LS with 24-inch concrete standpipe on unprotected side of canal.

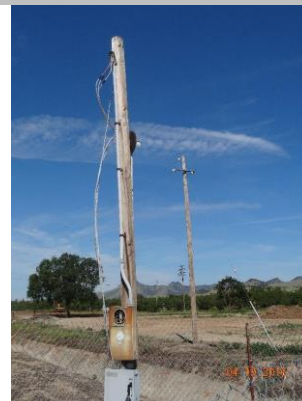
Photo 2 of 3 : UCIP\_FA\_2019\_55464\_74963.jpg

Meter removed from box and disconnected power lines

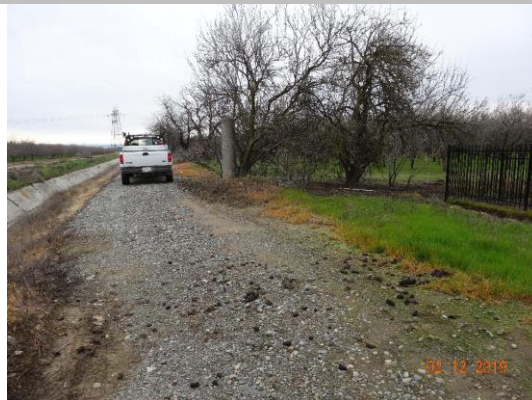
Photo 3 of 3 : UCIP\_FA\_2019\_55465\_78916.jpg

FIELD\_STRUCT\_DESC: 24-inch reinforced concrete drainage pipe through the levee (high ground levee), 2 feet below the crown. Flap gate is located on the outlet visible on the waterside (WS). Inlet is about 430 feet from WS outlet on Butte Avenue. (24-inch pipe authorized under Permit No. 12746, 1979 - Dan Garcia; Name change and flap gate authorized for existing 24-inch pipe under Permit No. 12746-1, 2016 - County of Sutter).  
FS Date: 2/12/2019 10:19:00 AM

Overview of levee crown looking east towards crossings (24- and 8-inch pipes).

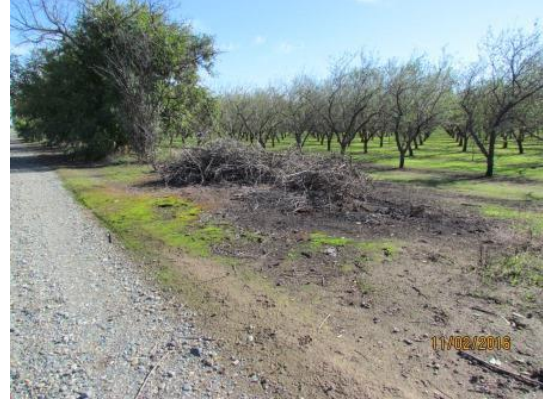
Photo 1 of 1 : FA\_2019\_ST0020\_213\_19\_20190822\_00007.jpg

LM Start	1.12	Rating **	M	Issue No.	19
LM End	1.12	Issue Type +	En	Location *	LS
Category	Earthen Levee			GPS Latitude/Longitude	
				Start	End
Item	Encroachments			39.171284 °	39.171284 °
				-121.739272 °	-121.739272 °
DWR ID	DWR_ST0020_01_f_2016_19				
Comment Code					
PR : Prunings					
Inspector Comment					
Remove prunings from the landside toe.

View of the prunings along the landside toe.

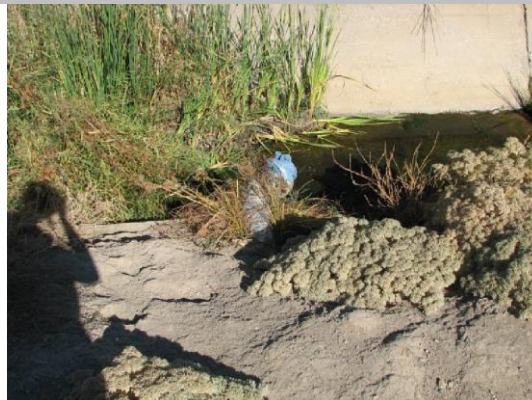
Photo 1 of 3 : UCIP\_FA\_2019\_55467\_11347.jpg

Comment Code						
Inspector Comment						
DS_ID:19433 FS_ID:55467 EP_NO: 15946 Repair Type: Non-Urgent Crossing Status: Found UCIP Comments: 02/12/2019 Unit 1 known as the West Levee (West Interceptor Canal) is considered a high ground levee with no defined levee prism, any issue found along this Unit will be considered a maintenance issue or an unauthorized encroachment. System description was updated based on permit records and field observations. Crossing has been updated to a drainage pipe and not an irrigation pipe. Record has been updated from No Action Needed to Non-Urgent due to some damage observed on the WS slope. Damage to the WS slope should be addressed as part of the maintenance requirement. (O. Magana - DWR UCIP)4/10/2017 Crossing appears to be in good condition. (DWR Sutter Yard- A Freitag)10/11/2016 Crossing appears to be in good condition.(DWR Sutter Yard - a Freitag)4/19/2016 Crossing appears to be in good condition.5/12/2015 Crossing appears in good condition. No noticeable issues to report.5/15/2013 Same as last inspection.11/4/2013 Same as last inspection.5/12/2014 Same as last inspection.11/17/2014 Same as last inspection. FIELD_STRUCT_DESC: 6-inch polyvinyl chloride (PVC) drainage pipe through the levee (high ground levee), 2 feet below the crown. Flap gate located on the waterside (WS). Pipe runs from building on the landside (LS) toe to canal. Line is an intermittent line only that conveys water from over-pressure relief and bypass valves in a municipal water pump station on adjacent Sutter Community Services District property. Permit was issued for a 6-inch polyvinyl chloride (PVC) water line to be allowed outside the project levee section and outside 10 feet of the levee toes and steel within the project levee section. (6-inch and 12-inch pipes, different locations, authorized under Permit No. 15946, 1992 - Sutter Community Services District; design sketch available in permit, page 21-23). FS Date: 2/12/2019 10:19:00 AM

Pipe at LS shoulder next to canal.

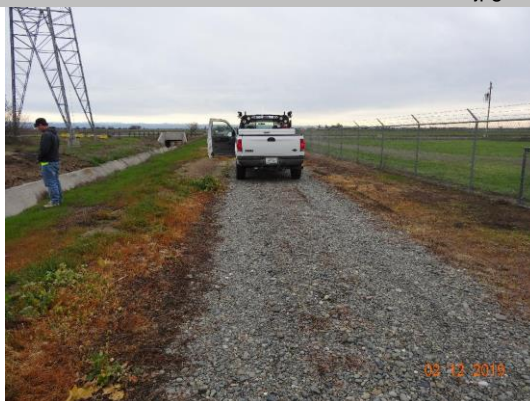
Photo 3 of 3 : UCIP\_FA\_2019\_55467\_78926.jpg

Overview of levee crown (high ground) looking east where pipe crosses.

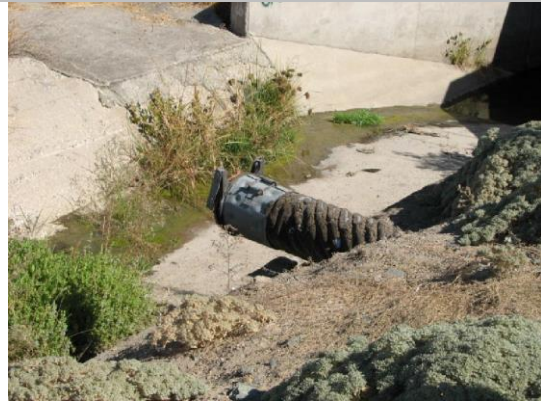
Photo 1 of 3 : UCIP\_FA\_2019\_55468\_11350.jpg

Comment Code					
Inspector Comment					
DS_ID:19432 FS_ID:55468 EP_NO: 15946 Repair Type: Non-Urgent Crossing Status: Found UCIP Comments: 02/12/2019 Unit 1 known as the West Levee (West Interceptor Canal) is considered a high ground levee with no defined levee prism, any issue found along this Unit will be considered a maintenance issue or an unauthorized encroachment. Record has been updated from No Action Needed to Non-Urgent due to some erosion and scour visible on the WS. Erosion and scour hole visible on the WS slope should be addressed as part of the maintenance for this high ground levee. (O. Magana - DWR UCIP)04/10/2017 Crossing appears to be in good condition. (DWR Sutter Yard-AFreitag)10/11/2016 Crossing appears to be in good condition. (DWR Sutter Yard - afreitag)04/19/2016 LS inlet has been cleaned out. Crossing appears in good condition.05/12/2015 LS inlet is still completely blocked with soil.11/17/2014 Same as last inspection.05/12/2014 Same as last inspection.05/15/2013 Same as last inspection.11/04/2013 Same as last inspection.10/16/2012 Inlet is completely blocked with soil. FIELD_STRUCT_DESC: 12-inch corrugated metal drainage pipe through the levee (high ground levee), 2 feet below the crown. Pipe is encased in concrete. Flap gate is located on the waterside (WS). Landside (LS) inlet filled with soil. (12-inch and 6-inch pipes, different locations, authorized under Permit No. 15946, 1992 - Sutter Community Services District; design sketch available in permit, page 21-23). FS Date: 2/12/2019 10:19:00 AM

Coated CMP at outlet.

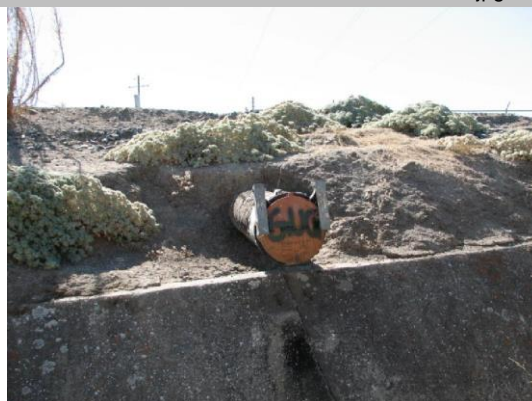
Photo 2 of 3 : UCIP\_FA\_2019\_55468\_11349.jpg

Flap gate and pipe at canal.

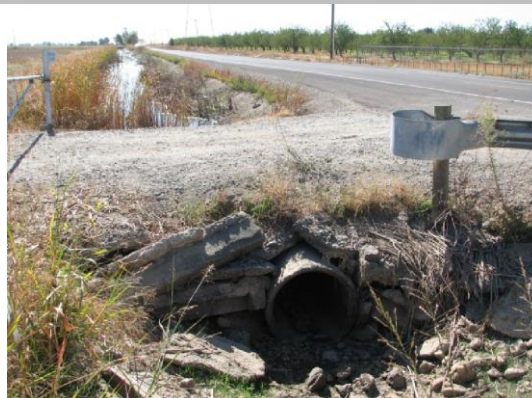
Photo 1 of 3 : UCIP\_FA\_2019\_55469\_11353.jpg

Comment Code						
Inspector Comment						
DS_ID:19422						
FS_ID:55469						
EP_NO: N/A						
Repair Type: Non-Urgent						
Crossing Status: Found						
UCIP Comments: 02/12/2019 Unit 1 known as the West Levee (West Interceptor Canal) is considered a high ground levee with no defined levee prism, any issue found along this Unit will be considered a maintenance issue or an unauthorized encroachment. Record has been updated from No Action Needed to Non-Urgent, no permit was found authorizing crossing. (O. Magana - DWR UCIP)04/10/2017 Crossing appears to be in good condition. Pipe material is concrete. (DWR Sutter Yard- AFreitag)10/11/2016 Crossing appears to be in good condition. (DWR Sutter Yard - afreitag)04/19/2016 Crossing appears to be in good condition.05/12/2015 Crossing appears in good condition. No noticeable issues to report.11/17/2014 Same as last inspection.05/12/2014 Same as last inspection.11/04/2013 Same as last inspection.05/15/2013 Same as last inspection.

WS of pipe at outlet.

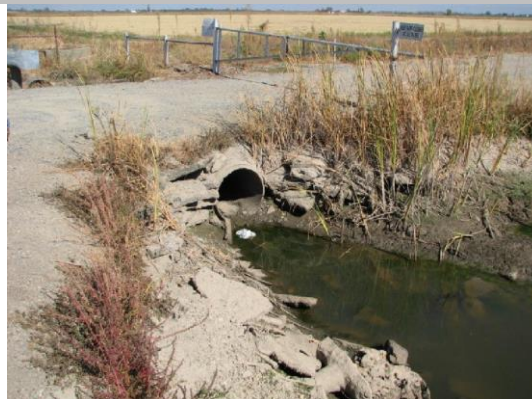
Photo 2 of 3 : UCIP\_FA\_2019\_55469\_11352.jpg

LS of pipe at inlet.

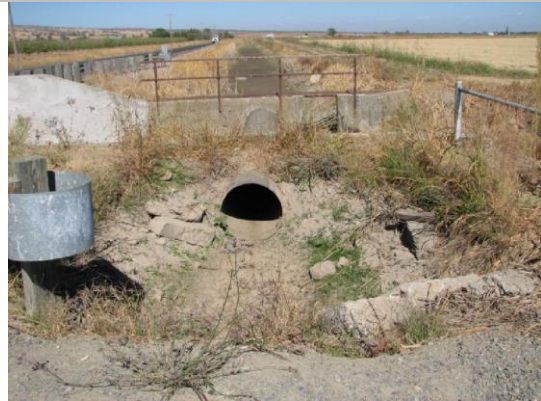
Photo 3 of 3 : UCIP\_FA\_2019\_55469\_11351.jpg

FIELD_STRUCT_DESC: 30-inch reinforced concrete irrigation pipe through the levee, 2 feet below the crown. 30-inch steel pipe also passes over canal in same alignment. [Additional Reference(s): DWR Levee Log, Revised 1990].						
FS Date: 2/12/2019 10:20:00 AM

30-inch steel pipe crossing over canal.

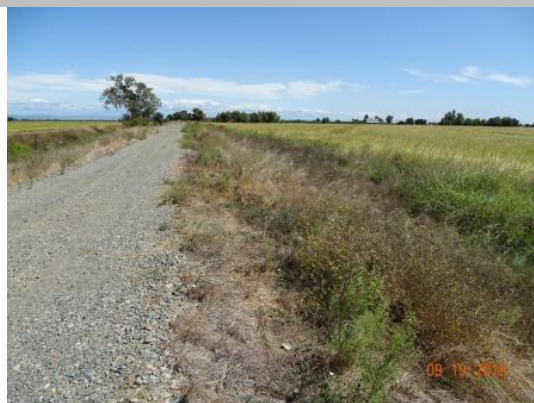
Photo 1 of 1 : FA\_2019\_ST0020\_214\_34\_20190920\_00082.jpg

LM Start	0.01	Rating **	M	Issue No.	34
LM End	0.26	Issue Type +	Ma	Location *	LS
Category	Earthen Levee			GPS Latitude/Longitude	
				Start	End
Item	Vegetation			39.171159 °	39.171024 °
				-121.726173 °	-121.721526 °
DWR ID	DWR_ST0020_02_f _ 2019_34				
Comment Code					
V1 : Control annual grass and weeds on the levee slopes and easements.					
Inspector Comment

View of the vegetation along the landside slope. Fall 2019.

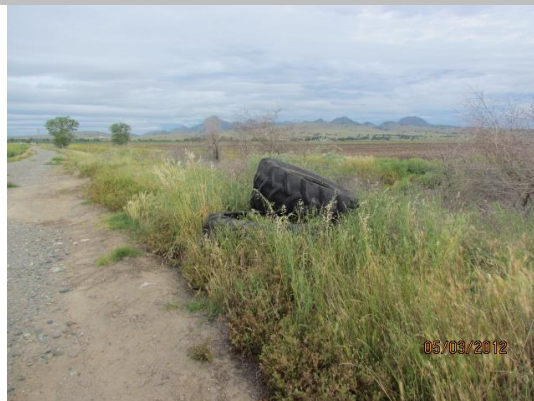
Photo 1 of 1 : FA\_2019\_ST0020\_214\_12\_20190822\_00006.jpg

LM Start	0.23	Rating **	M	Issue No.	12
LM End	0.23	Issue Type +	En	Location *	WS
Category	Earthen Levee			GPS Latitude/Longitude	
				Start	End
Item	Encroachments			39.171094 °	39.171094 °
				-121.722129 °	-121.722129 °
DWR ID	DWR_NA0020_02_s_2012_12				
Comment Code					
GA : Garbage					
Inspector Comment					
Tires should be removed from the waterside shoulder.

View of the tires along the WS toe.

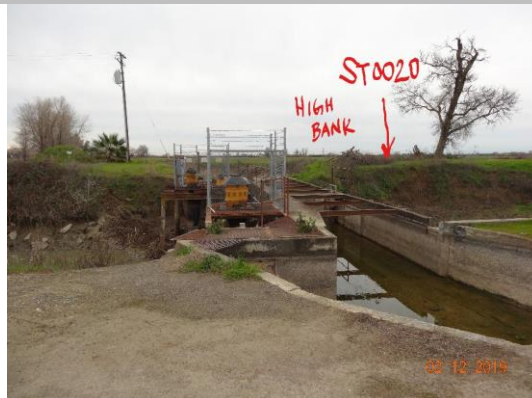
Photo 1 of 3 : UCIP\_FA\_2019\_55470\_78937.jpg

Overview of levee crown(high ground) photo taken from opposite bank.

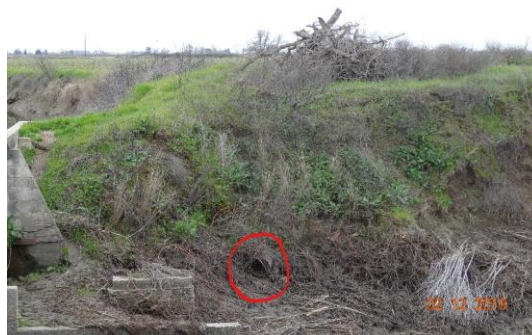
Photo 2 of 3 : UCIP\_FA\_2019\_55470\_78939.jpg

WS view: evidence that 15-inch pipe is still present through levee.

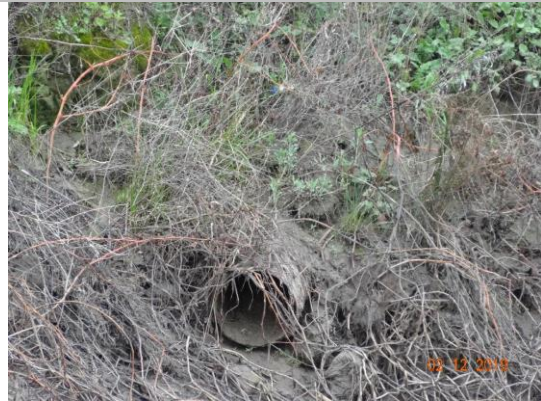
Photo 3 of 3 : UCIP\_FA\_2019\_55470\_78938.jpg

Comment Code						
Inspector Comment						
DS_ID:19424 FS_ID:55470 EP_NO: N/A Repair Type: Non-Urgent Crossing Status: Found UCIP Comments: 02/12/2019 Unit 2 known as the East Levee (East Interceptor Canal) is considered a high ground levee with no defined levee prism, any issue found along this Unit will be considered a maintenance issue, an unauthorized encroachment, or an abandoned encroachment. Record has been updated from No Action Needed to Non-Urgent, no permit has been found authorizing pipe and pipe has been abandoned. Pump and power pole have been removed. 15-inch pipe through the levee was found. Limited access to levee, UCIP inspection was completed by accessing the opposite bank. Pipe has been abandoned. (O. Magana - DWR UCIP)04/10/2017 Unable to locate. (DWR Sutter Yard- AFreitag)10/11/2016 Unable to locate.04/19/2016 Unable to locate.05/12/2015 Unable to locate.11/17/2014 Unable to locate.05/12/2014 Same as last inspection.11/04/2013 Same as last inspection.5/15/2013 Same as last inspection. Unable to locate.10/16/2012 Unable to locate. FIELD_STRUCT_DESC: 15-inch galvanized iron irrigation pipe through the levee (high ground levee), at an unknown depth. 15 horsepower (HP) pump and power pole located on the waterside (WS). [Additional Reference(s): DWR Levee Log, 1990. USACE Sacramento O&M Manual 135, May 1953, (HLM 0.27), Page 11, Location Section 10, As-Built Drawing No. 50-10-2816]. FS Date: 2/12/2019 12:15:00 PM

WS view: pipe found through bank.

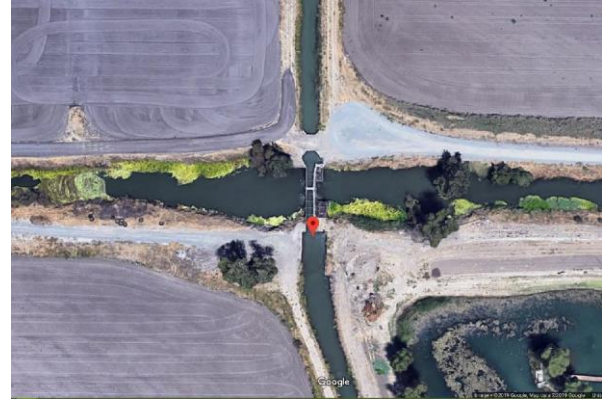
Photo 1 of 3 : UCIP\_FA\_2019\_55471\_78946.jpg

Overview of structure through non-levee section.

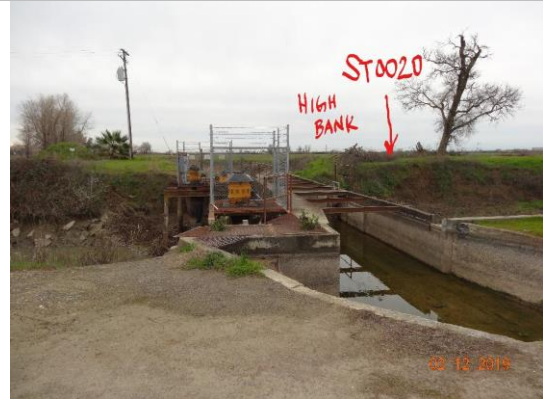
Photo 2 of 3 : UCIP\_FA\_2019\_55471\_78940.jpg

Overview of levee section (high ground) where pumping structure is located, photo taken from opposite bank.

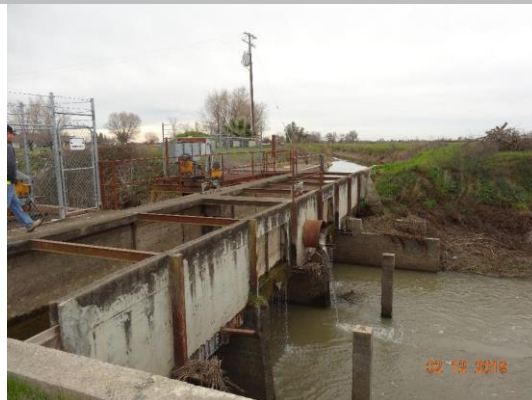
Photo 3 of 3 : UCIP\_FA\_2019\_55471\_78941.jpg

Comment Code						
Inspector Comment						
DS_ID:20116 FS_ID:55471 EP_NO: N/A Repair Type: Non-Urgent Crossing Status: Found UCIP Comments: 02/12/2019 Unit 2 known as the East Levee (East Interceptor Canal) is considered a high ground levee with no defined levee prism, any issue found along this Unit will be considered a maintenance issue, an unauthorized encroachment, or an abandoned encroachment. Record has been updated from No Action Needed to Non-Urgent, no permit has been identified authorizing pipe. The pump station is located inside the canal. (O. Magana - DWR UCIP)04/10/2017 Crossing appears to be in good condition. (DWR Sutter Yard- AFreitag)10/11/2016 Crossing appears to be in good condition. (DWR Sutter Yard - afreitag)04/19/2016 Crossing appears to be in good condition.05/12/2015 Crossing appears in good condition. No noticeable issues to report.11/17/2014 Same as last inspection.05/12/2014 Same as last inspection.11/04/2013 Same as last inspection.05/15/2013 Same as last inspection. FIELD_STRUCT_DESC: 22-inch steel irrigation pipe through the levee (high ground levee), 2.5 feet below the crown. Pumping plant located on the waterside (WS) shoulder. Pipe, flap gate, vent, and headwall located on the landside (LS) in canal. Metal pier in stream with flap gate on the LS. 8-inch standpipe/vent on the LS. No permit has been identified since crossing was field discovered in 2012. FS Date: 2/12/2019 12:16:00 PM

WS view: irrigation structure (west side), photo taken from opposite bank.

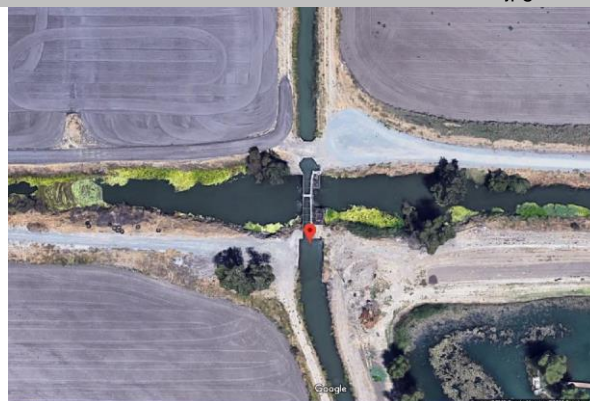
Photo 1 of 3 : UCIP\_FA\_2019\_55472\_78953.jpg

Comment Code						
Inspector Comment						
DS_ID:20117 FS_ID:55472 EP_NO: N/A Repair Type: Non-Urgent Crossing Status: Found UCIP Comments: 02/12/2019 Unit 2 known as the East Levee (East Interceptor Canal) is considered a high ground levee with no defined levee prism, any issue found along this Unit will be considered a maintenance issue, an unauthorized encroachment, or an abandoned encroachment. Record has been updated from No Action Needed to Non-Urgent, no permit has been identified authorizing pipe. The pump station is located inside the canal. (O. Magana - DWR UCIP)04/10/2017 Crossing appears to be in good condition. (DWR Sutter Yard- AFreitag)10/11/2016 Crossing appears to be in good condition. (DWR Sutter Yard - afreitag)04/19/2016 Crossing appears to be in good condition.05/12/2015 Crossing appears in good condition. No noticeable issues to report.11/17/2014 Same as last inspection.05/12/2014 Same as last inspection.11/04/2013 Same as last inspection.05/15/2013 Same as last inspection. FIELD_STRUCT_DESC: 32-inch steel irrigation pipe through the levee (high ground levee), 2.5 feet below the crown. Pipe, flap gate, vent, and headwall located on the landside (LS) in canal. Metal pier in stream with flap gate on the LS. 8-inch standpipe/vent located on the LS. No permit has been identified since crossing was field discovered in 2012. FS Date: 2/12/2019 12:16:00 PM

Overview of structure through non-levee section.

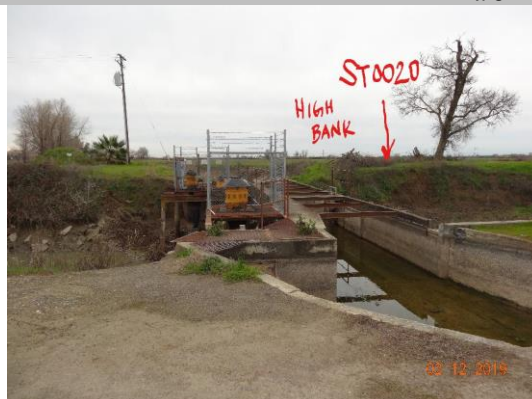
Photo 2 of 3 : UCIP\_FA\_2019\_55472\_78947.jpg

Overview of levee section (high ground) where pumping structure is located, photo taken from opposite bank.

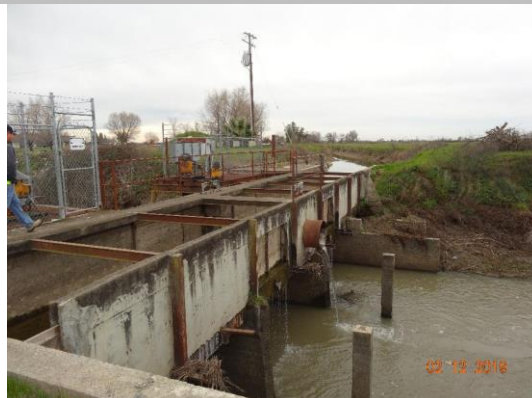
Photo 3 of 3 : UCIP\_FA\_2019\_55472\_78948.jpg

FIELD_STRUCT_DESC: 32-inch steel irrigation pipe through the levee (high ground levee), 2.5 feet below the crown. Pipe, flap gate, vent, and headwall located on the landside (LS) in canal. Metal pier in stream with flap gate on the LS. 8-inch standpipe/vent located on the LS. No permit has been identified since crossing was field discovered in 2012.						
FS Date: 2/12/2019 12:16:00 PM

WS view: irrigation structure (west side), photo taken from opposite bank.

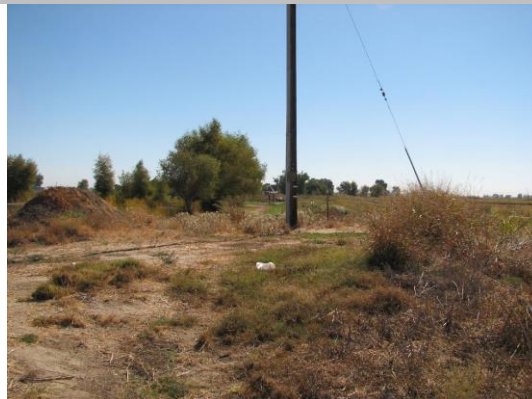
Photo 2 of 3 : UCIP\_FA\_2019\_55473\_14332.jpg

power pole likely end point for pipe.

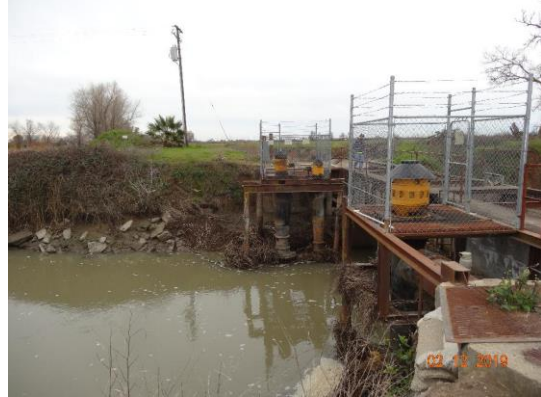
Photo 3 of 3 : UCIP\_FA\_2019\_55473\_78956.jpg

WS view: irrigation structure (east side), photo taken from opposite bank.

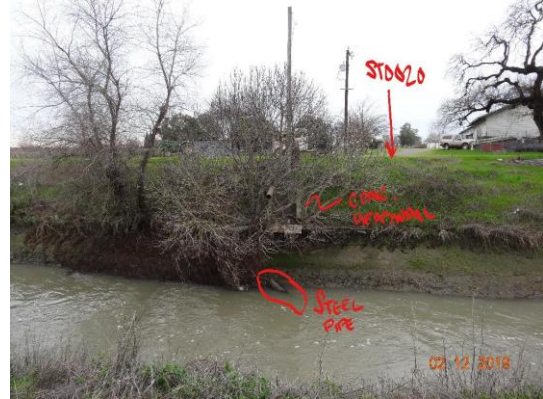
Photo 1 of 3 : UCIP\_FA\_2019\_55474\_78958.jpg

DS\_ID:19425  
FS\_ID:55474  
EP\_NO: N/A  
Repair Type: Non-Urgent  
Crossing Status: Found  
UCIP Comments: 02/12/2019 Unit 2 known as the East Levee (East Interceptor Canal) is considered a high ground levee with no defined levee prism, any issue found along this Unit will be considered a maintenance issue, an unauthorized encroachment, or an abandoned encroachment. Record remains Non-Urgent, pipe and appurtenances have been abandoned. No permit has been identified authorizing this pipe. Concrete "U" headwall was visible from opposite bank. (O. Magana - DWR UCIP)04/10/2017 Abandoned. (DWR Sutter Yard - A Freitag)10/11/2016 Abandoned crossing.(DWR Sutter Yard - a Freitag)04/19/2016 Abandoned crossing.05/12/2015 Abandoned crossing.11/17/2014 Same as last inspection.05/12/2014 Same as last inspection.11/04/2013 Same as last inspection.05/15/2013 Same as last inspection.10/16/2012 Pipe and pump abandoned. Pipe should be removed or properly abandoned.

Overview of levee section (high ground), photo taken from opposite bank.

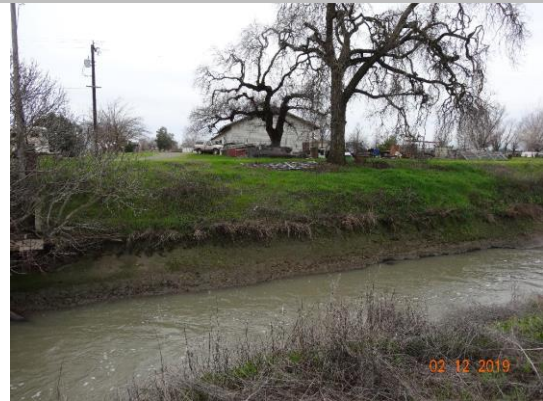
Photo 2 of 3 : UCIP\_FA\_2019\_55474\_78959.jpg

Overview of levee section (high ground), photo taken from opposite bank just upstream from pipe crossing.

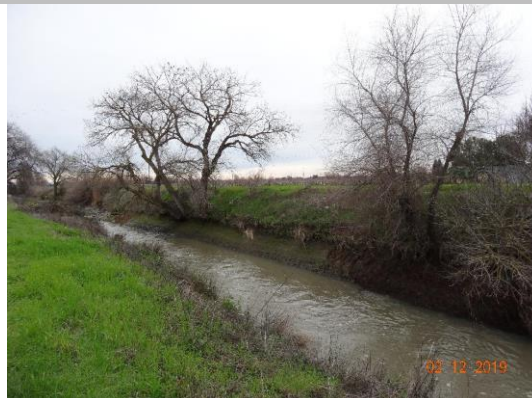
Photo 3 of 3 : UCIP\_FA\_2019\_55474\_78960.jpg

Overview of levee section (high ground), photo taken from opposite bank just downstream from pipe crossing.

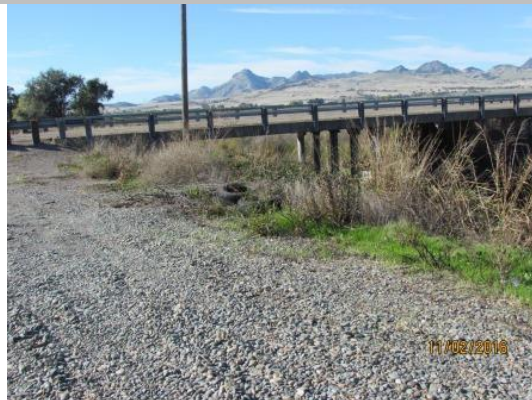
Photo 1 of 1 : FA\_2019\_ST0020\_214\_28\_20190822\_00008.jpg

LM Start	0.53	Rating **	M	Issue No.	28
LM End	0.53	Issue Type +	En	Location *	WS
Category	Earthen Levee			GPS Latitude/Longitude	
				Start	End
Item	Encroachments			39.171028 °	39.171028 °
				-121.716475 °	-121.716475 °
DWR ID	DWR_ST0020_02_s _ 2016_28				
Comment Code					
DE : Debris					
Inspector Comment					
Tires and tree clippings should be removed from the waterside shoulder.

View of the tires along the waterside berm.

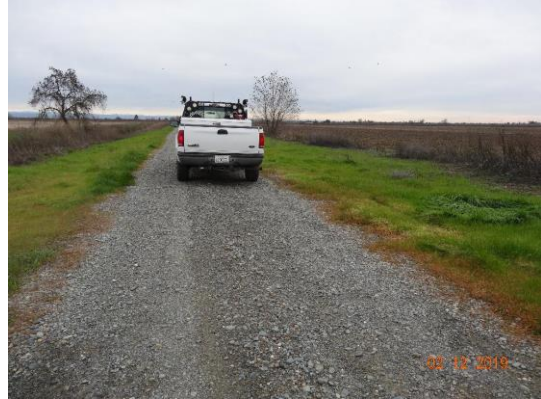
Photo 1 of 3 : UCIP\_FA\_2019\_55475\_78964.jpg

Comment Code					
Inspector Comment					
DS_ID:19426 FS_ID:55475 EP_NO: N/A Repair Type: Non-Urgent Crossing Status: Found UCIP Comments: 02/12/2019 Unit 2 known as the East Levee (East Interceptor Canal) is considered a high ground levee with no defined levee prism, any issue found along this Unit will be considered a maintenance issue, an unauthorized encroachment, or an abandoned encroachment. Record remains Non-Urgent, pipe and appurtenances have been abandoned. No permit has been identified authorizing this pipe. Power meter has been removed. (O. Magana - DWR UCIP)04/10/2017 Abandoned. (DWR Sutter Yard-AFreitag)10/11/2016 Abandoned crossing.(DWR Sutter Yard -afreitag)04/19/2016 Abandoned crossing.05/12/2015 Abandoned crossing. Needs to be properly abandoned.11/17/2014 Same as last inspection.05/12/2014 Same as last inspection.11/04/2013 Same as last inspection.05/15/2013 Same as last inspection.10/16/2012 Pumping plant abandoned. Pipe abandoned and only visible at bottom of concrete standpipe. Pipe needs to be abandoned properly. FIELD_STRUCT_DESC: 12-inch galvanized iron irrigation pipe through the levee, 6 feet below the crown (high ground levee). 10 horsepower (HP) pump in the canal, and power pole located on the waterside (WS). 36-inch concrete standpipe located on the landside (LS) shoulder. [Additional Reference(s): DWR Levee Log, 1990. USACE Sacramento O&M Manual 135, May 1953, (HLM 0.74), Page 11, Location Section 19, As-Built Drawing No. 50-10-2816]. FS Date: 2/12/2019 12:18:00 PM

Overview of levee section (high ground) where pipe crosses.

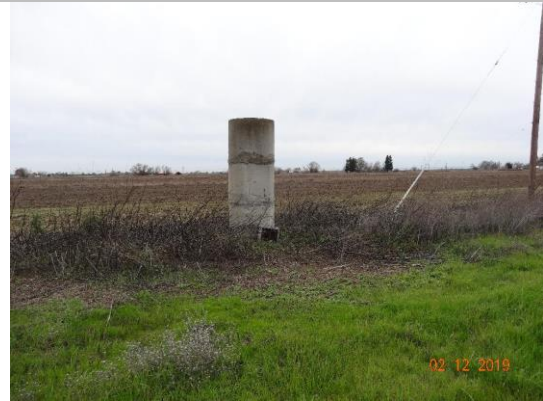
Photo 2 of 3 : UCIP\_FA\_2019\_55475\_78963.jpg

LS view: concrete standpipe located on the LS.

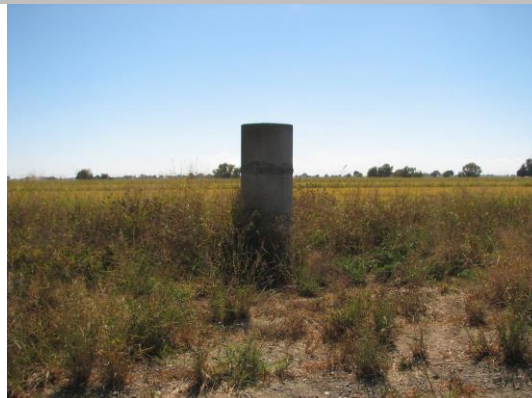
Photo 3 of 3 : UCIP\_FA\_2019\_55475\_11391.jpg

Concrete standpipe on LS shoulder.

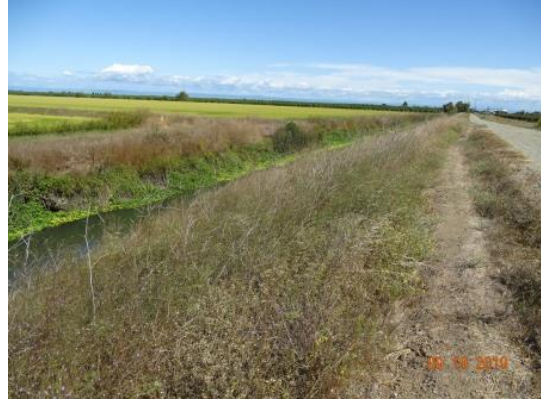
Photo 1 of 1 : FA\_2019\_ST0020\_214\_37\_20190920\_00083.jpg

LM Start	1.01	Rating **	M	Issue No.	37
LM End	1.31	Issue Type +	Ma	Location *	WS
Category	Earthen Levee			GPS Latitude/Longitude	
				Start	End
Item	Vegetation			39.170916°	39.170826°
				-121.707632°	-121.701979°
DWR ID	DWR_ST0020_02_f_2019_37				
Comment Code					
V1 : Control annual grass and weeds on the levee slopes and easements.					
Inspector Comment

View of the vegetation along the waterside slope. Fall 2019.

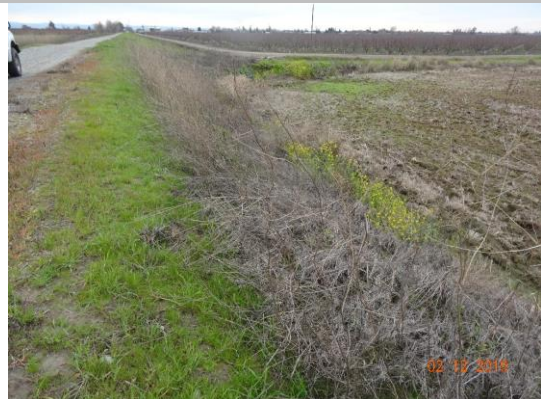
Photo 1 of 3 : UCIP\_FA\_2019\_55476\_78969.jpg

Comment Code					
Inspector Comment					
DS_ID:19431 FS_ID:55476 EP_NO: N/A Repair Type: Non-Urgent Crossing Status: Not Found UCIP Comments: 02/12/2019 Unit 2 known as the East Levee (East Interceptor Canal) is considered a high ground levee with no defined levee prism, any issue found along this Unit will be considered a maintenance issue, an unauthorized encroachment, or an abandoned encroachment. Record has been updated from No Action Needed to Non-Urgent, status of pipe through the levee is unknown. DWR DMP Geophysical Investigation could not confirm pipe crossing. Record will remain on the UCIP inspection list. (O. Magana - DWR UCIP)04/10/2017 Unable to locate. (DWR Sutter Yard-AFreitag)10/11/2016 Unable to locate.(DWR Sutter Yard -afreitag)04/19/2016 Unable to locate.05/12/2015 Unable to locate.11/17/2014 Unable to locate.05/12/2014 Same as last inspection.11/04/2013 Same as last inspection.05/15/2013 Same as last inspection. Unable to locate.10/16/2012 Unable to locate FIELD_STRUCT_DESC: 24-inch corrugated metal drainage pipe through the levee (high ground levee), 8 feet below the crown. [Additional Reference(s): DWR Levee Log, Revised 1990]. FS Date: 2/12/2019 12:18:00 PM

LS view: overview of LS no evidence of pipe found.

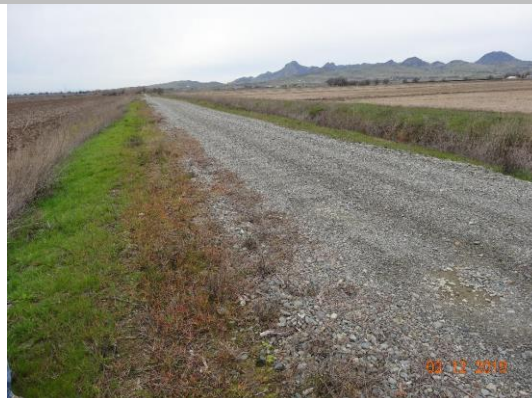
Photo 2 of 3 : UCIP\_FA\_2019\_55476\_78967.jpg

Overview of levee section (high ground) where pipe should cross.

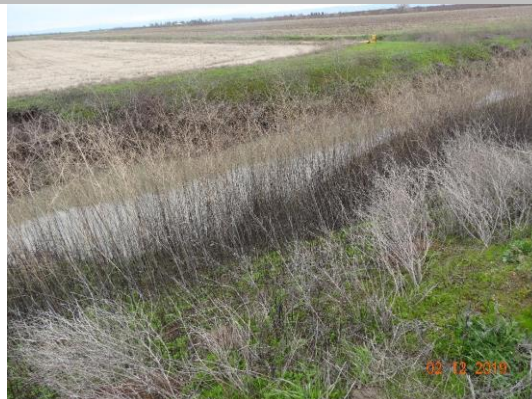
Photo 3 of 3 : UCIP\_FA\_2019\_55476\_78968.jpg

WS view: overview of WS no evidence of pipe found.

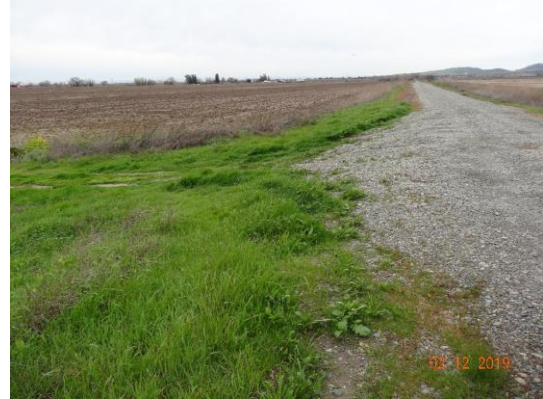
Photo 1 of 3 : UCIP\_FA\_2019\_55893\_78970.jpg

Comment Code						
Inspector Comment						
DS_ID:19439 FS_ID:55893 EP_NO: N/A Repair Type: Non-Urgent Crossing Status: Not Found UCIP Comments: 02/12/2019 Unit 2 known as the East Levee (East Interceptor Canal) is considered a high ground levee with no defined levee prism, any issue found along this Unit will be considered a maintenance issue, an unauthorized encroachment, or an abandoned encroachment. Record has been updated from No Action Needed to Non-Urgent, status of pipe through high ground levee is unknown. DWR DMP Geophysical Investigation could not confirm pipe crossing. Record will remain on the UCIP inspection list. (O. Magana - DWR UCIP)04/10/2017 Unable to locate. (DWR Sutter Yard - A Freitag)10/11/2016 Unable to locate.(DWR Sutter Yard - A Freitag)04/19/2016 Unable to locate.05/12/2015 Unable to locate.11/17/2014 Unable to locate10/16/2012 likely pipe underwater.05/12/2014 Same as last inspection.11/04/2013 Same as last inspection.05/15/2013 Same as last inspection. Unable to locate.10/16/2012 Unable to locate. FIELD_STRUCT_DESC: 30-inch corrugated metal drainage pipe through the levee (high ground levee), at an unknown depth. [Additional Reference(s): USACE Sacramento O&M Manual 135, May 1953, (HLM 1.04), Page 11, Location Section 22, As-Built Drawing No. 50-10-2816]. FS Date: 2/12/2019 12:19:00 PM

LS view: overview of LS no evidence of pipe found.

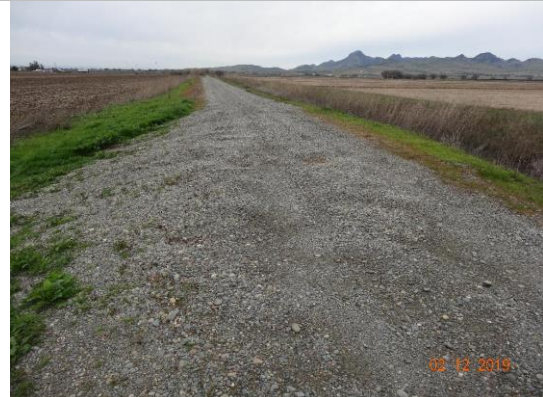
Photo 2 of 3 : UCIP\_FA\_2019\_55893\_78971.jpg

Overview of levee section (high ground) where pipe should cross.

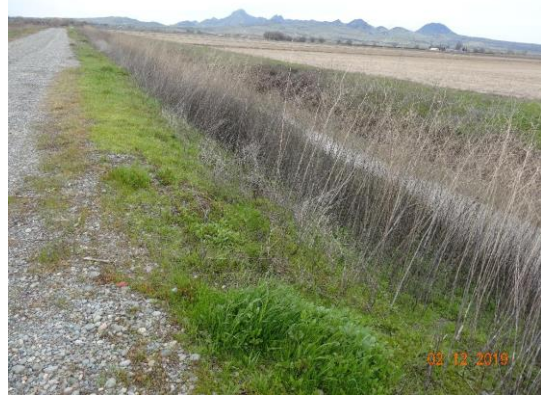
Photo 3 of 3 : UCIP\_FA\_2019\_55893\_78972.jpg

WS view: overview of WS no evidence of pipe found.

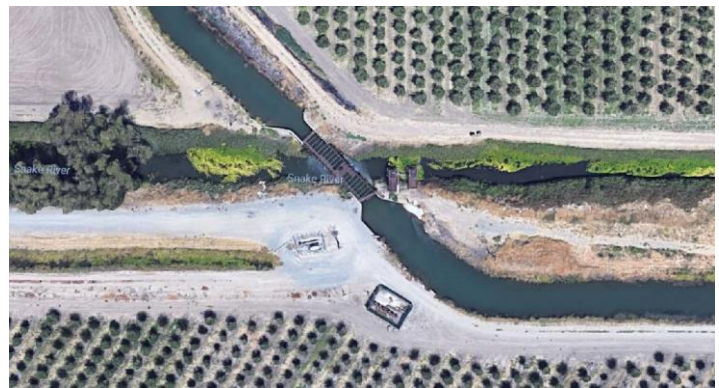
Photo 1 of 3 : UCIP\_FA\_2019\_55478\_78979.jpg

Comment Code						
Inspector Comment						
DS_ID:19429 FS_ID:55478 EP_NO: N/A Repair Type: Non-Urgent Crossing Status: Found UCIP Comments: 02/12/2019 Unit 2 known as the East Levee (East Interceptor Canal) is considered a high ground levee with no defined levee prism, any issue found along this Unit will be considered a maintenance issue, an unauthorized encroachment, or an abandoned encroachment. Record has been updated from No Action Needed to Non-Urgent, no permit has been found authorizing pipe. (O. Magana - DWR UCIP)04/10/2017 Crossing appears to be in good condition. (DWR Sutter Yard- A Freitag)10/11/2016 Crossing appears to be in good condition. (DWR Sutter Yard - a Freitag)04/19/2016 Crossing appears to be in good condition.05/12/2015 Crossing appears in good condition. No noticeable issues to report.11/17/2014 Same as last inspection.05/12/2014 Same as last inspection.11/04/2013 Same as last inspection.05/15/2013 Same as last inspection. FIELD_STRUCT_DESC: 1 of 2: 36-inch steel irrigation pipe through the levee (high ground levee), 2 feet below the crown. Pump house on platform in canal. Flap gates in Sutter Slough. 7-inch diameter air vent riser located on the landside (LS) shoulder. Power pole on levee with electrical box. [Additional Reference(s): DWR Levee Logs, Revised 1990] FS Date: 2/12/2019 12:19:00 PM

Overview of structure through the non-levee section.

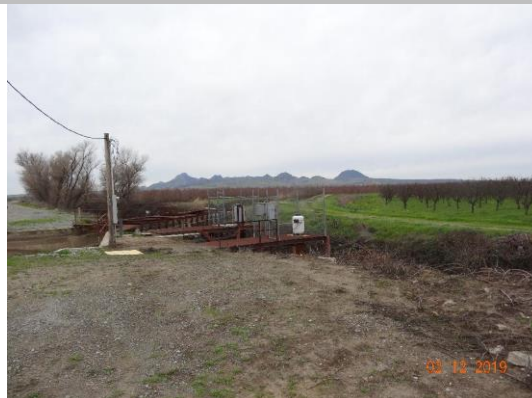
Photo 2 of 3 : UCIP\_FA\_2019\_55478\_78973.jpg

Overview of structure located on the the East-West Interceptor, photo 1 of 2.

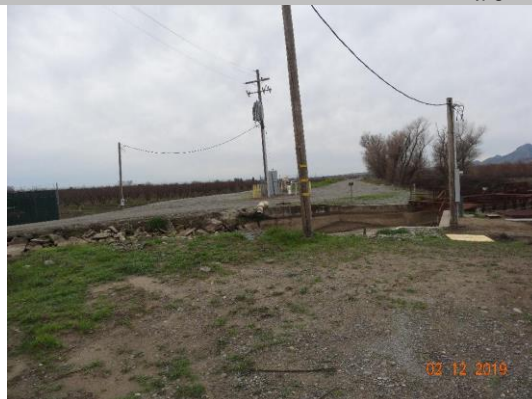
Photo 3 of 3 : UCIP\_FA\_2019\_55478\_78974.jpg

Overview of structure located on the the East-West Interceptor, photo 2 of 2.

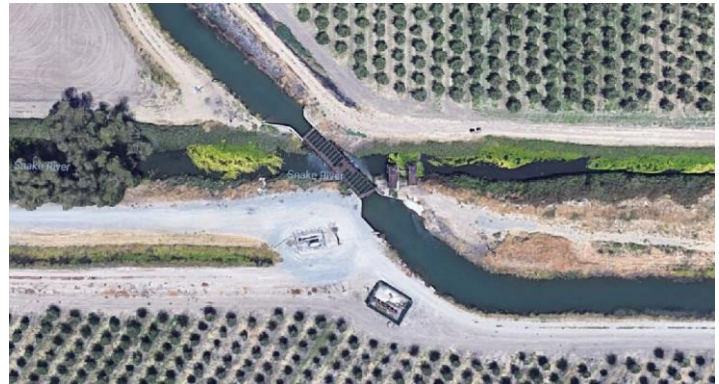
Photo 1 of 3 : UCIP\_FA\_2019\_55479\_78980.jpg

Comment Code						
Inspector Comment						
DS_ID:19440 FS_ID:55479 EP_NO: N/A Repair Type: Non-Urgent Crossing Status: Found UCIP Comments: 02/12/2019 Unit 2 known as the East Levee (East Interceptor Canal) is considered a high ground levee with no defined levee prism, any issue found along this Unit will be considered a maintenance issue, an unauthorized encroachment, or an abandoned encroachment. Record has been updated from No Action Needed to Non-Urgent, no permit has been found authorizing pipe. (O. Magana - DWR UCIP)04/10/2017 Crossing appears to be in good condition. (DWR Sutter Yard- AFreitag)10/11/2016 Crossing appears to be in good condition.(DWR Sutter Yard - afreitag)04/19/2016 Crossing appears to be in good condition.05/12/2015 Crossing appears in good condition. No noticeable issues to report.11/17/2014 Same as last inspection.5/12/2014 Same as last inspection.11/4/2013 Same as last inspection.5/15/2013 Same as last inspection. FIELD_STRUCT_DESC: 2 of 2: 24-inch steel irrigation pipe through the levee (high ground levee), at an unknown depth below the crown. Siphon breaker located on the landside (LS) shoulder. Pump house on platform in canal on the waterside (WS). Flap gate in Sutter Slough. Power pole on levee with electrical box. [Additional Reference(s): DWR Levee Logs, Revised 1990] FS Date: 2/12/2019 12:21:00 PM

Overview of structure through the non-levee section.

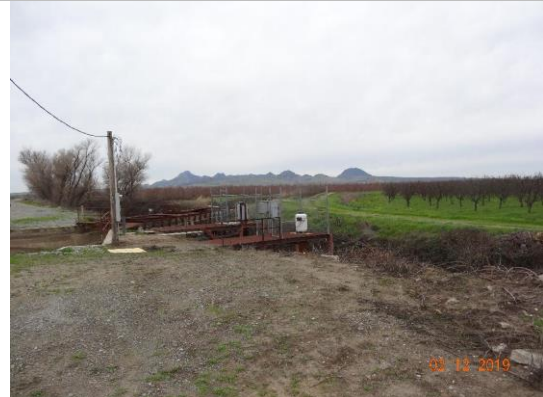
Photo 2 of 3 : UCIP\_FA\_2019\_55479\_78981.jpg

Overview of structure located on the East-West Interceptor, photo 1 of 2.

Comment Code						
Inspector Comment						
DS_ID:19440 FS_ID:55479 EP_NO: N/A Repair Type: Non-Urgent Crossing Status: Found UCIP Comments: 02/12/2019 Unit 2 known as the East Levee (East Interceptor Canal) is considered a high ground levee with no defined levee prism, any issue found along this Unit will be considered a maintenance issue, an unauthorized encroachment, or an abandoned encroachment. Record has been updated from No Action Needed to Non-Urgent, no permit has been found authorizing pipe. (O. Magana - DWR UCIP)04/10/2017 Crossing appears to be in good condition. (DWR Sutter Yard- AFreitag)10/11/2016 Crossing appears to be in good condition.(DWR Sutter Yard - afreitag)04/19/2016 Crossing appears to be in good condition.05/12/2015 Crossing appears in good condition. No noticeable issues to report.11/17/2014 Same as last inspection.5/12/2014 Same as last inspection.11/4/2013 Same as last inspection.5/15/2013 Same as last inspection. FIELD_STRUCT_DESC: 2 of 2: 24-inch steel irrigation pipe through the levee (high ground levee), at an unknown depth below the crown. Siphon breaker located on the landside (LS) shoulder. Pump house on platform in canal on the waterside (WS). Flap gate in Sutter Slough. Power pole on levee with electrical box. [Additional Reference(s): DWR Levee Logs, Revised 1990] FS Date: 2/12/2019 12:21:00 PM

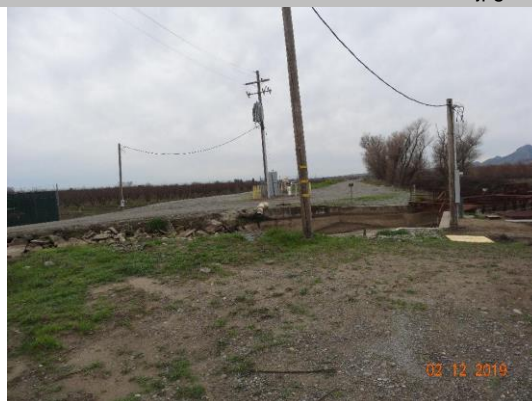
Photo 3 of 3 : UCIP\_FA\_2019\_55479\_78982.jpg

Overview of structure located on the East-West Interceptor, photo 2 of 2.

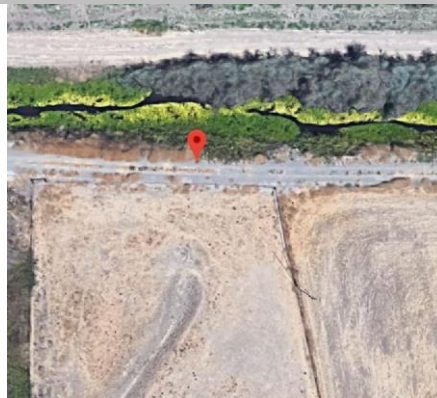
Photo 1 of 3 : UCIP\_FA\_2019\_55563\_78992.jpg

UCIP Comments: 02/12/2019 Unit 2 known as the East Levee (East Interceptor Canal) is considered a high ground levee with no defined levee prism, any issue found along this Unit will be considered a maintenance issue, an unauthorized encroachment, or an abandoned encroachment. Record remains Non-Urgent, no permit has been found authorizing pipe. LS inlet was excavated to remove soil buildup. Barbed wire fence prevents access to LS inlet. Property owner has complained to the maintaining LMA (Sutter Yard) of flooding issues associated with clogged pipe and property owner would like the LMA to clean pipe. Need to determine ownership of pipe. (O. Magana - DWR UCIP)04/10/2017 LS inlet is buried, WS pipe outlet is overgrown with the flap gate being the only thing that is barely visible. (DWR Sutter Yard- AFreitag)10/11/2016 LS inlet is buried and WS flap gate is overgrown with blackberries.(DWR Sutter Yard - afreitag)04/19/2016 WS flap gate is completely overgrown with blackberries. 05/12/2015 LS inlet still buried with soil and blackberries on WS have blocked the flap gate.11/17/2014 Ws outlet of pipe is overgrown and blocked from opening by blackberries. LS inlet still appears to be buried/blocked by soil.05/12/2014 Same as last inspection.11/04/2013 Same as last inspection.05/15/2013 Same as last inspection.10/16/2012 LS intake is filled and blocked with soil. (W. Wylie - DWR UCIP) FIELD\_STRUCT\_DESC: 16-inch corrugated metal drainage pipe through the levee (high ground levee), 5 feet below the crown. Flap gate located on the waterside (WS) end. Landside (LS) inlet filled and blocked with soil in 2012. [Additional Reference(s): DWR Levee Log, Revised 1990].

Overview of landside drainage path across levee section.

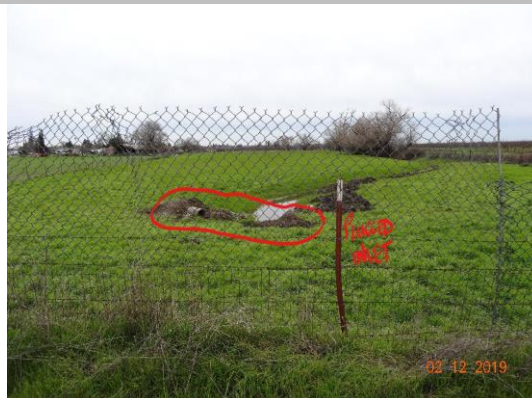
Photo 3 of 3 : UCIP\_FA\_2019\_55563\_78988.jpg

DS\_ID:19423  
FS\_ID:55563  
EP\_NO: N/A  
Repair Type: Non-Urgent  
Crossing Status: Found  
UCIP Comments: 02/12/2019 Unit 2 known as the East Levee (East Interceptor Canal) is considered a high ground levee with no defined levee prism, any issue found along this Unit will be considered a maintenance issue, an unauthorized encroachment, or an abandoned encroachment. Record remains Non-Urgent, no permit has been found authorizing pipe. LS inlet was excavated to remove soil buildup. Barbed wire fence prevents access to LS inlet. Property owner has complained to the maintaining LMA (Sutter Yard) of flooding issues associated with clogged pipe and property owner would like the LMA to clean pipe. Need to determine ownership of pipe. (O. Magana - DWR UCIP)04/10/2017 LS inlet is buried, WS pipe outlet is overgrown with the flap gate being the only thing that is barely visible. (DWR Sutter Yard- AFreitag)10/11/2016 LS inlet is buried and WS flap gate is overgrown with blackberries.(DWR Sutter Yard - afreitag)04/19/2016 WS flap gate is completely overgrown with blackberries. 05/12/2015 LS inlet still buried with soil and blackberries on WS have blocked the flap gate.11/17/2014 Ws outlet of pipe is overgrown and blocked from opening by blackberries. LS inlet still appears to be buried/blocked by soil.05/12/2014 Same as last inspection.11/04/2013 Same as last inspection.05/15/2013 Same as last inspection.10/16/2012 LS intake is filled and blocked with soil. (W. Wylie - DWR UCIP) FIELD\_STRUCT\_DESC: 16-inch corrugated metal drainage pipe through the levee (high ground levee), 5 feet below the crown. Flap gate located on the waterside (WS) end. Landside (LS) inlet filled and blocked with soil in 2012. [Additional Reference(s): DWR Levee Log, Revised 1990].

LS view: plugged inlet.

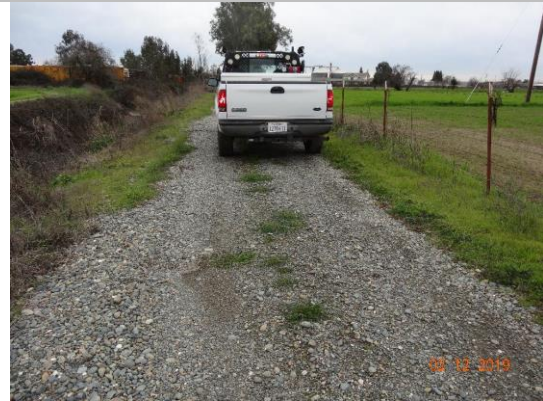
Photo 1 of 3 : UCIP\_FA\_2019\_55481\_78994.jpg

Comment Code					
Inspector Comment					
DS_ID:19430 FS_ID:55481 EP_NO: N/A Repair Type: Non-Urgent Crossing Status: Indicator Found UCIP Comments: 02/12/2019 Unit 2 known as the East Levee (East Interceptor Canal) is considered a high ground levee with no defined levee prism, any issue found along this Unit will be considered a maintenance issue, an unauthorized encroachment, or an abandoned encroachment. No pipe was found. Record has been updated from No Action Needed to Non-Urgent, no permit has been found authorizing pipe. Unable to determine the status of 4-inch pipe. Recommend removing dense vegetation to determine if pipe has been abandoned or recommend conducting geophysical investigation through this section of high ground levee to determine if any signal of metal pipe is detected. (O. Magana - DWR UCIP)04/10/2017 Unable to locate any sign of this crossing on the WS. (DWR Sutter Yard-AFreitag)10/11/2016 Still unable to see where this crosses through the levee.(DWR Sutter Yard - afreitag)04/19/2016 Still unable to see where pipe crosses through the levee.05/12/2105 Unable to locate where pipe crosses though levee.11/17/2014 Same as last inspection.05/12/2014 Same as last inspection.11/04/2013 Same as last inspection.05/15/2013 Same as last inspection.10/16/2012 unable to locate pipe through levee. FIELD_STRUCT_DESC: 4-inch pipe through the levee (high ground levee), 4-feet below the crown. Pump next to junction box located on the landside (LS) 40 feet from LS shoulder. [Additional Reference(s): DWR Levee Log, Revised 1990] FS Date: 2/12/2019 12:22:00 PM

Overview of levee section (high ground) where pipe crosses.

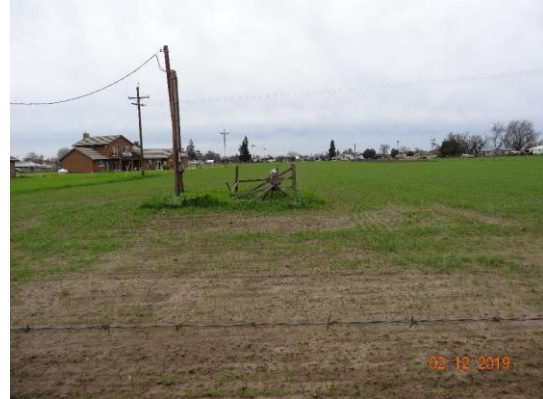
Photo 2 of 3 : UCIP\_FA\_2019\_55481\_78993.jpg

Comment Code					
Inspector Comment					
DS_ID:19430 FS_ID:55481 EP_NO: N/A Repair Type: Non-Urgent Crossing Status: Indicator Found UCIP Comments: 02/12/2019 Unit 2 known as the East Levee (East Interceptor Canal) is considered a high ground levee with no defined levee prism, any issue found along this Unit will be considered a maintenance issue, an unauthorized encroachment, or an abandoned encroachment. No pipe was found. Record has been updated from No Action Needed to Non-Urgent, no permit has been found authorizing pipe. Unable to determine the status of 4-inch pipe. Recommend removing dense vegetation to determine if pipe has been abandoned or recommend conducting geophysical investigation through this section of high ground levee to determine if any signal of metal pipe is detected. (O. Magana - DWR UCIP)04/10/2017 Unable to locate any sign of this crossing on the WS. (DWR Sutter Yard-AFreitag)10/11/2016 Still unable to see where this crosses through the levee.(DWR Sutter Yard - afreitag)04/19/2016 Still unable to see where pipe crosses through the levee.05/12/2105 Unable to locate where pipe crosses though levee.11/17/2014 Same as last inspection.05/12/2014 Same as last inspection.11/04/2013 Same as last inspection.05/15/2013 Same as last inspection.10/16/2012 unable to locate pipe through levee. FIELD_STRUCT_DESC: 4-inch pipe through the levee (high ground levee), 4-feet below the crown. Pump next to junction box located on the landside (LS) 40 feet from LS shoulder. [Additional Reference(s): DWR Levee Log, Revised 1990] FS Date: 2/12/2019 12:22:00 PM

LS view: junction box located on the LS.

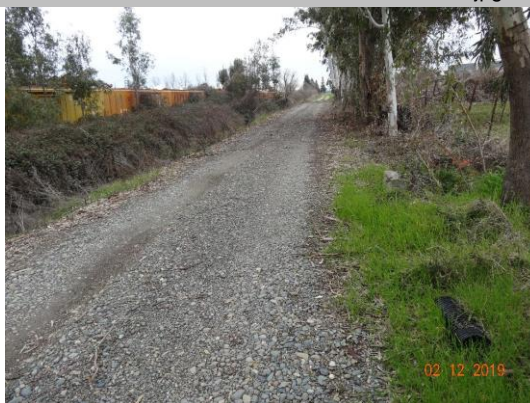
Photo 1 of 3 : UCIP\_FA\_2019\_55482\_78997.jpg

Comment Code						
Inspector Comment						
DS_ID:20119 FS_ID:55482 EP_NO: N/A Repair Type: Non-Urgent Crossing Status: Found UCIP Comments: 02/12/2019 Unit 2 known as the East Levee (East Interceptor Canal) is considered a high ground levee with no defined levee prism, any issue found along this Unit will be considered a maintenance issue, an unauthorized encroachment, or an abandoned encroachment. Record remains Non-Urgent, no permit has been found authorizing pipe. (O. Magana - DWR UCIP)04/10/2017 Crossing appears to be in good condition. (DWR Sutter Yard-AFreitag)10/11/2016 Crossing appears to be in good condition.(DWR Sutter Yard - afreitag)04/19/2016 Crossing appears to be in good condition.05/12/2015 Crossing appears in good condition. No noticeable issues to report.11/17/2014 Same as last inspection.05/12/2014 Same as last inspection.11/4/2013 Same as last inspection.05/15/2013 Same as last inspection.10/16/2012 No permit identified for crossing. FIELD_STRUCT_DESC: 5-inch aluminum drainage pipe through the levee (high ground levee), 1 foot below the crown. Flap gate located on the waterside (WS) with concrete headwall block on the landside (LS). No permit has been identified since crossing was field discovered in 2012. FS Date: 2/12/2019 12:23:00 PM

Overview of levee section (high ground) looking east, photo 1 of 2.

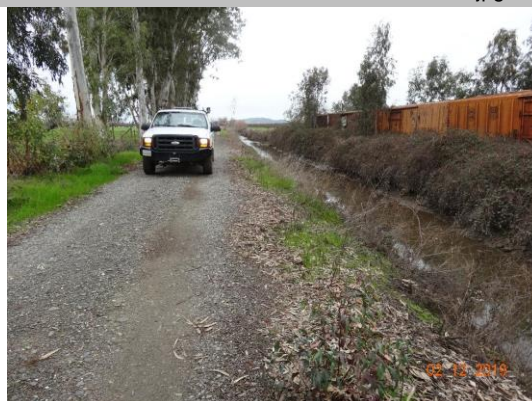
Photo 2 of 3 : UCIP\_FA\_2019\_55482\_78998.jpg

Comment Code						
Inspector Comment						
DS_ID:20119 FS_ID:55482 EP_NO: N/A Repair Type: Non-Urgent Crossing Status: Found UCIP Comments: 02/12/2019 Unit 2 known as the East Levee (East Interceptor Canal) is considered a high ground levee with no defined levee prism, any issue found along this Unit will be considered a maintenance issue, an unauthorized encroachment, or an abandoned encroachment. Record remains Non-Urgent, no permit has been found authorizing pipe. (O. Magana - DWR UCIP)04/10/2017 Crossing appears to be in good condition. (DWR Sutter Yard- AFreitag)10/11/2016 Crossing appears to be in good condition.(DWR Sutter Yard - afreitag)04/19/2016 Crossing appears to be in good condition.05/12/2015 Crossing appears in good condition. No noticeable issues to report.11/17/2014 Same as last inspection.05/12/2014 Same as last inspection.11/4/2013 Same as last inspection.05/15/2013 Same as last inspection.10/16/2012 No permit identified for crossing. FIELD_STRUCT_DESC: 5-inch aluminum drainage pipe through the levee (high ground levee), 1 foot below the crown. Flap gate located on the waterside (WS) with concrete headwall block on the landside (LS). No permit has been identified since crossing was field discovered in 2012. FS Date: 2/12/2019 12:23:00 PM

Overview of levee section (high ground) looking west, photo 2 of 2.
